# PEDSAFE:

## Pedestrian Safety Guide and Countermeasure Selection System

SEPTEMBER 2004

1. Report No. FHWA-SA-04-003	2. Government Accession No. PB2006-101168	3. Recipient's Catalog No.	
4. Title and Subtitle PEDSAFE: Pedestrian Safety Guide and Countermeasure Selection System		5. Report Date September 2004

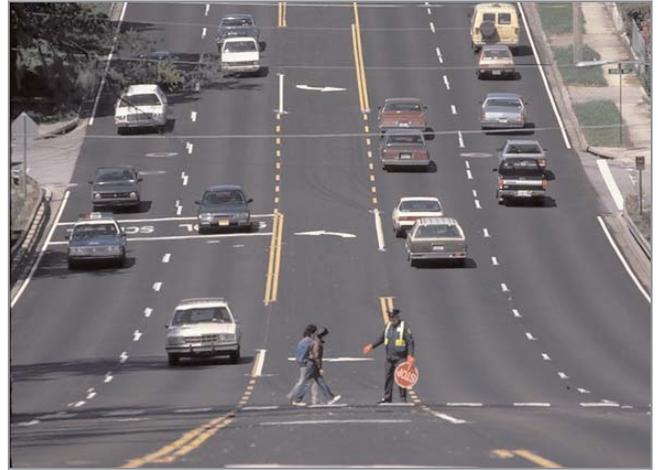
Wide multilane roadways without adequate crossing islands create an unsafe environment for many pedestrians.

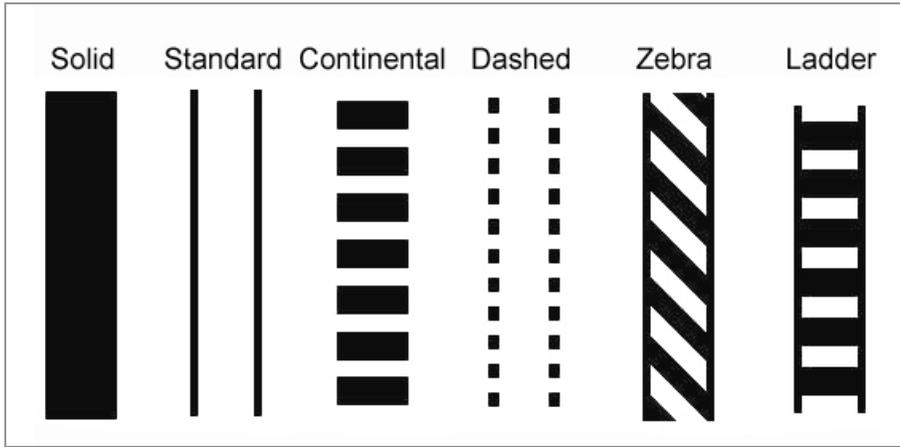
Examples of different crosswalk marking patterns.

traverse by those with diminished mobility or visual capabilities. Granite and cobblestones are examples of materials that are aesthetically pleasing, but may become slippery when wet or be difficult to cross by pedestrians who are blind or using wheelchairs. One of the best

materials for marking crosswalks is inlay tape, which is installed on new or repaved streets. It is highly reflective, long-lasting, and slip-resistant, and does not require a high level of maintenance. Although initially more costly than paint, both inlay tape and thermoplastic are more cost-effective in the long run. Inlay tape is recommended for new and resurfaced pavement, while thermoplastic may be a better option on rougher pavement surfaces. Both inlay tape and thermoplastic are more visible and less slippery than paint when wet.

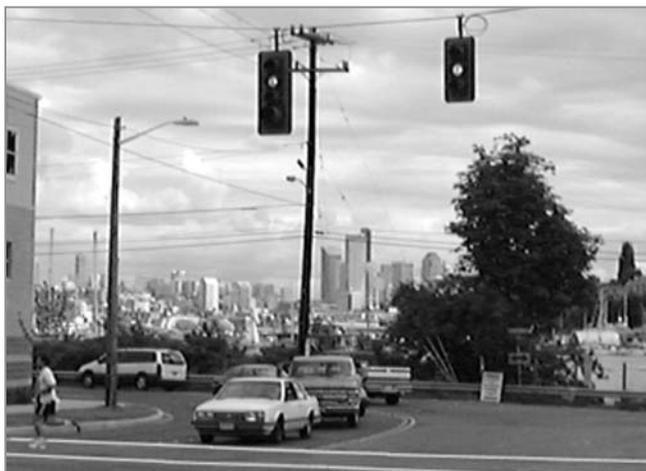
A traffic signal at a busy intersection with high volumes of pedestrians, bicyclists, and cars.

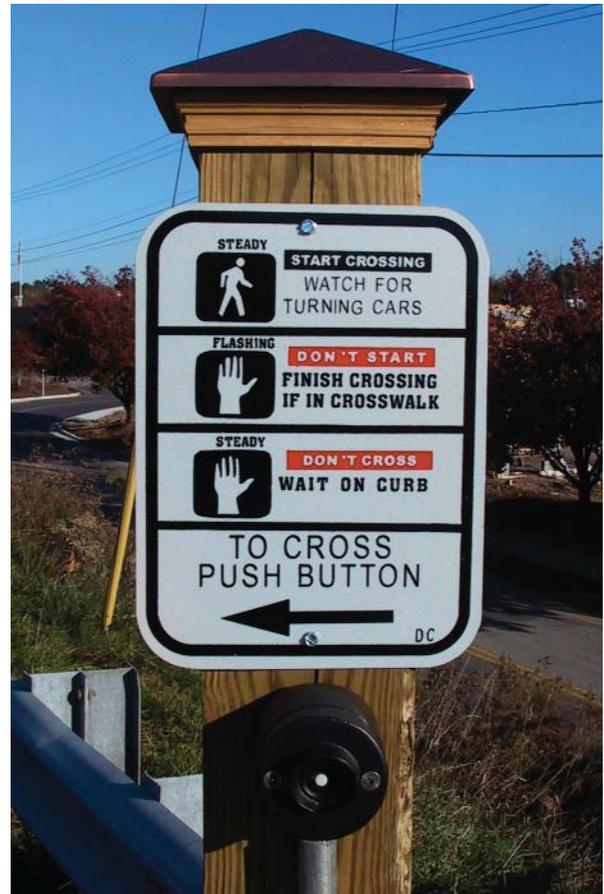
Example of an pedestrian regulatory sign used in conjunction with a pushbutton. The recommended language for such signs can be found in Section 2B.44 of the MUTCD.

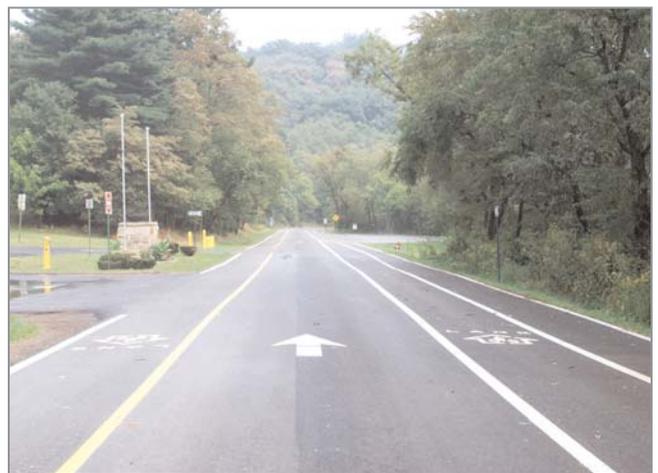
Striping of three travelways—center lane for one-way vehicle flow, a parallel flow bicycle lane on the right, and a contra-flow bicycle lane on the left.

Where space was limited and traffic patterns permitted, the roadway was designated as one-way, allowing continuation of all three travelways for the bicyclists and pedestrians. In this case, a bicycle lane with an adjacent pedestrian path

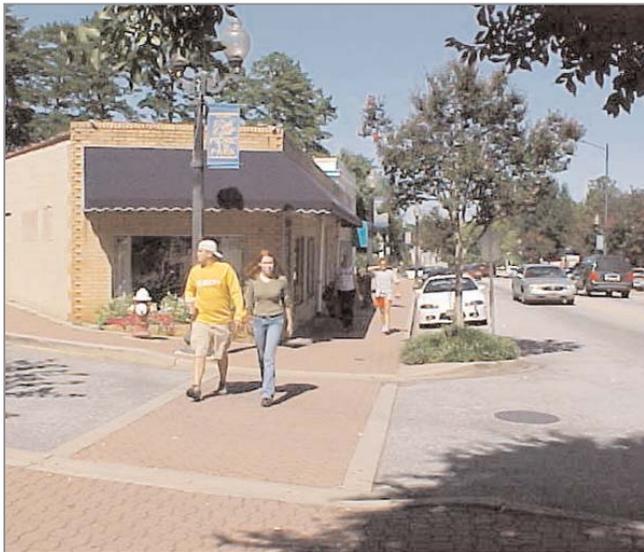
Pedestrian enhancements on College Avenue at Sloan Street include brick pavers, curb ramps, and new landscaping.

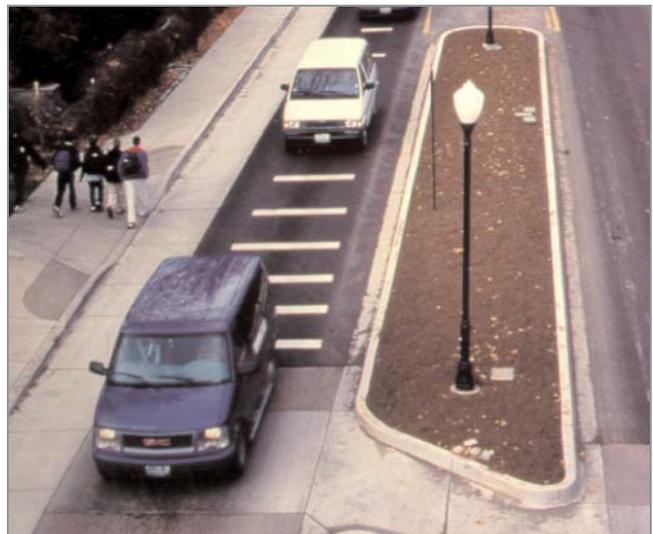
The sidewalks, raised medians, and raised crosswalks on First Street accommodate pedestrians effectively.

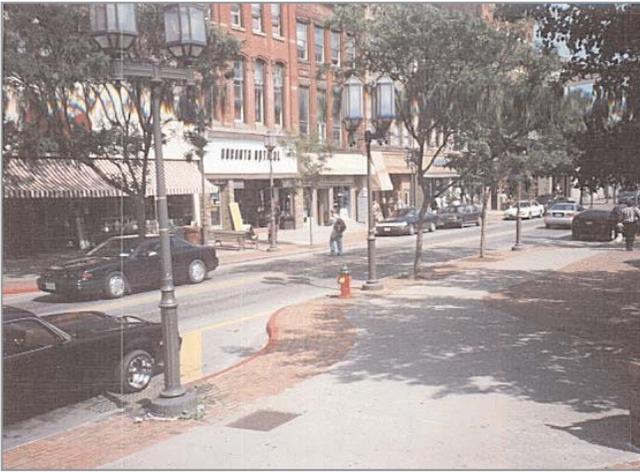
A mid-block curb extension on Main Street in Oneonta, NY narrows the street to two lanes and cuts the pedestrian crossing distance in half.

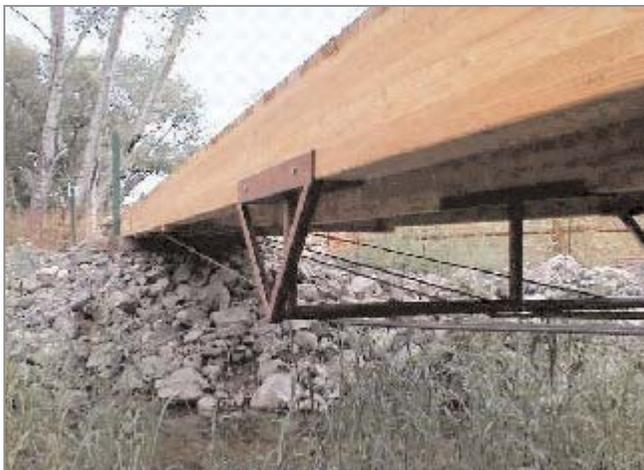
The Miller Creek permanent bridge tension frame was used to steady the bridge for pedestrians and bicyclists

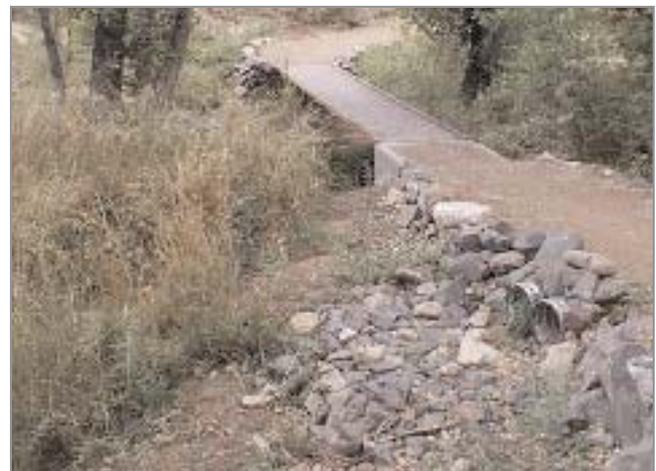
The Granite Creek bridge takes advantage of an existing sewer pipe as its foundation.

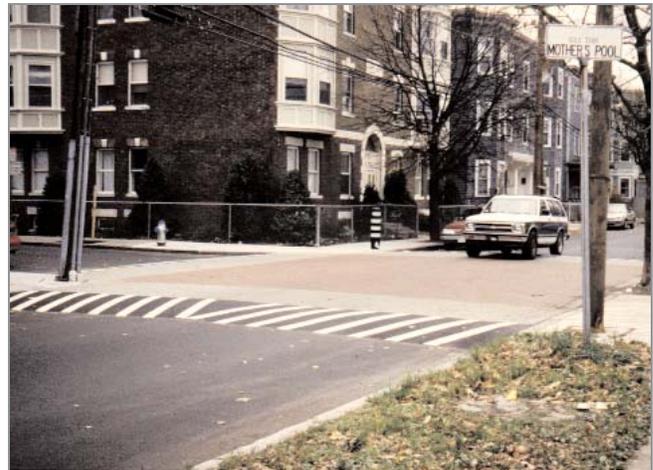
Raised intersection at Berkshire and Marcella Streets.

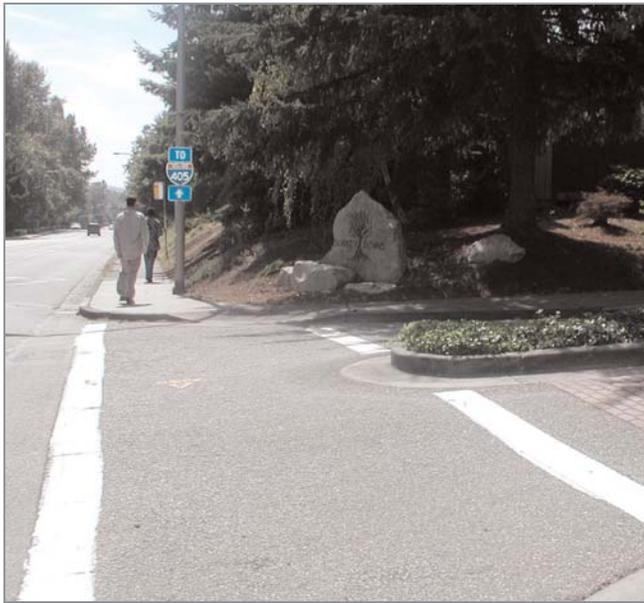
A landscaped island with pavement treatments at the entrance to the Surrey Downs neighborhood.

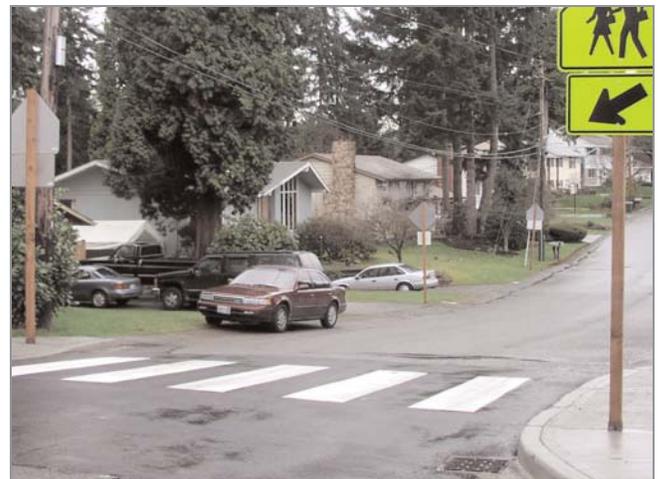
A raised crosswalk and curb extension along a street in the Bennett Elementary School Area.

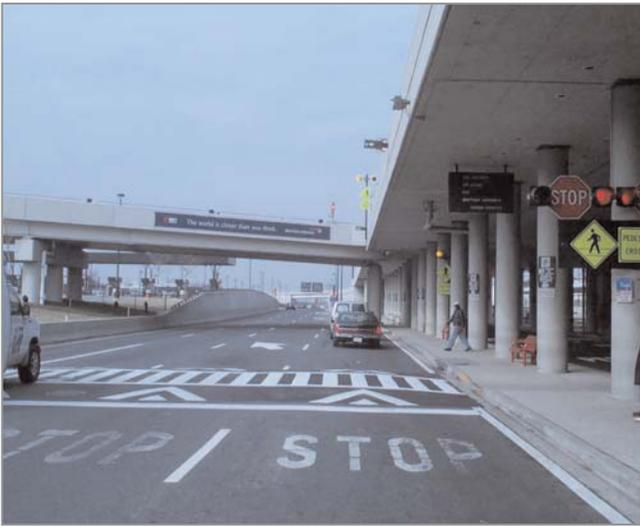
The speed tables at BWI improve crossing conditions for pedestrians. Note that the speed table is complemented by strong yellow-green pedestrian markings and STOP signs with flashing lights and pavement markings, which typically are not used in combination with speed tables.

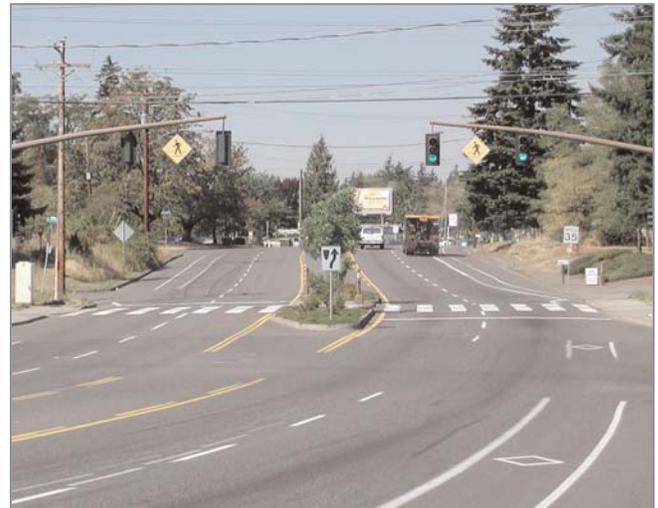
A typical major intersection treatment.

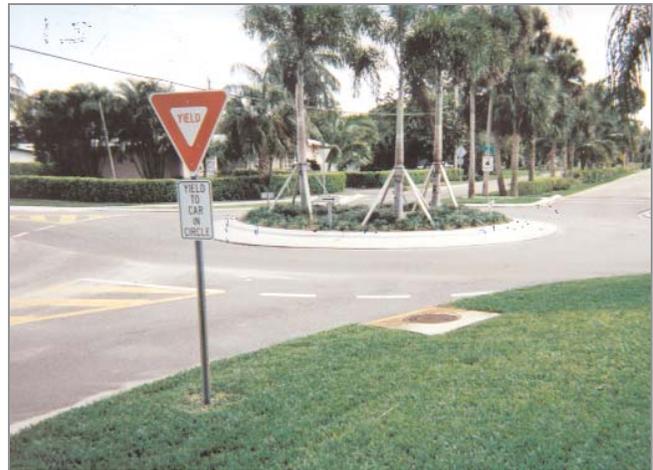
Median island and intersection roundabouts were installed on 7th Avenue.

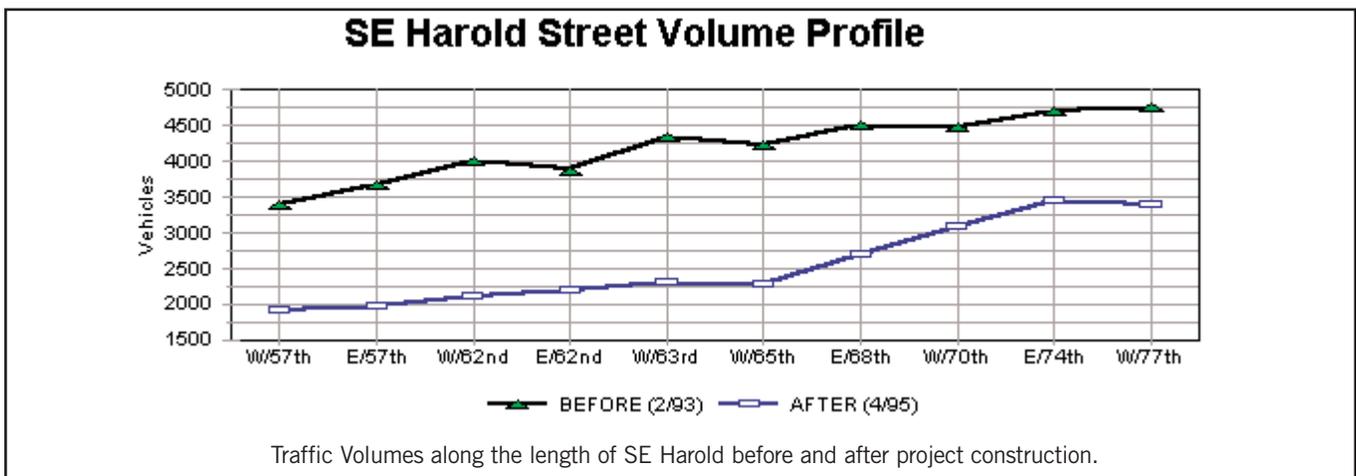
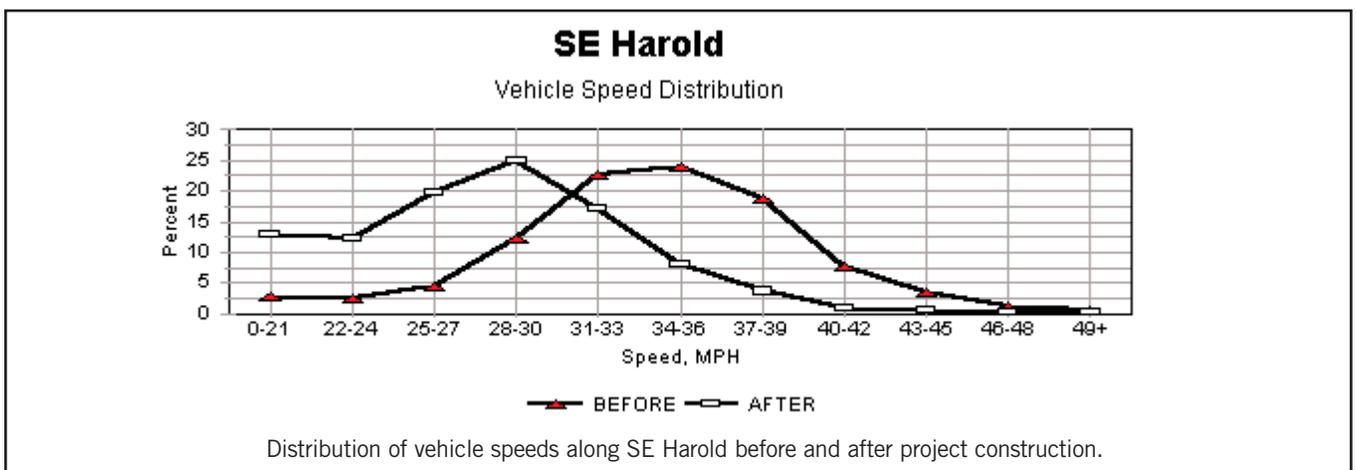
mi/h). The graph above shows that the peak in speeds has shifted from 55–58 km/h (34–36 mi/h) to 45–48 km/h (28–30 mi/h). The shape of the after curve indicates a concentration of the vehicle speeds. Also, a higher percent of vehicles are now traveling below the posted speed limit, which remained at 48 km/h (30 mi/h). A check of available Department of Motor Vehicle records for the 15 months before the speed bumps were constructed as compared to the same time period after construction shows the number of reported accidents dropped from 17 to 13. The number of injuries reported in those accidents also dropped from 16 to 8.

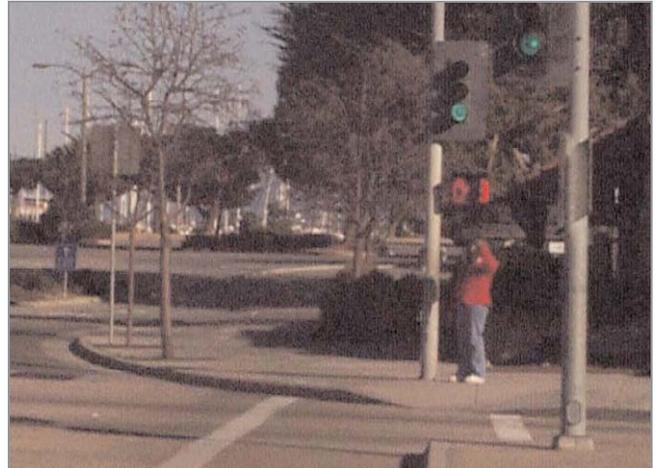
Monterey's countdown signals have been successful in discouraging some pedestrians from crossing with only a few seconds left in the phase.

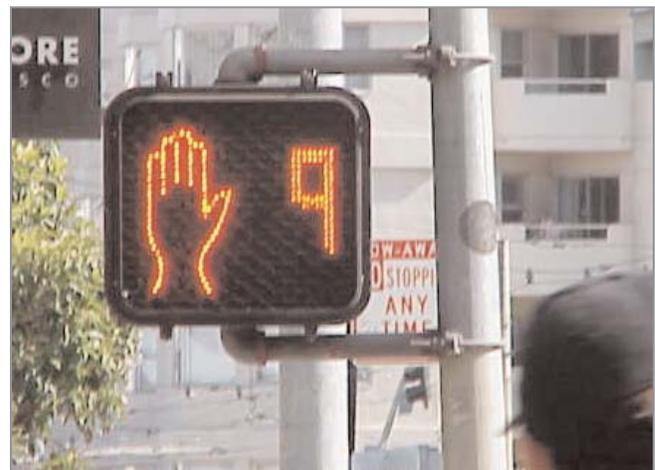
Pedestrian countdown signal heads show the time remaining for each phase.

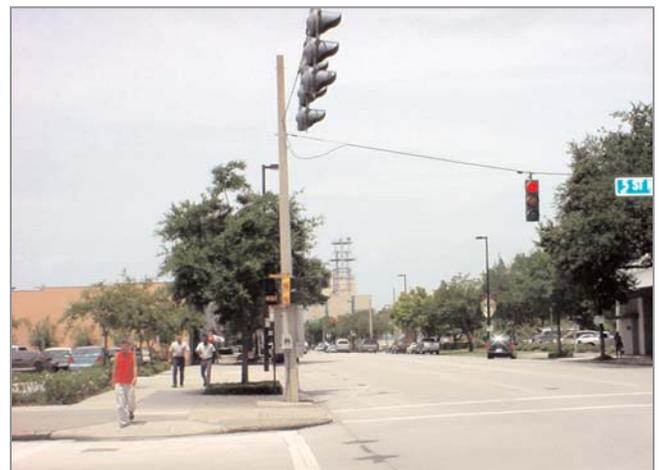
Pedestrians are given a WALK signal three seconds before parallel traffic is given a green light.

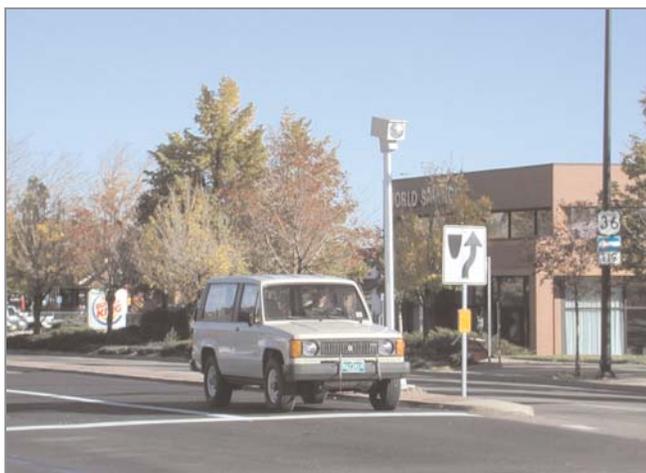
An intersection with camera enforcement.
